CECERBRICS FOR EROSION-CONTROL& FOUNDATIONS

Dr. Mahesh D. Desai Ph.D. (Civil Engg), Visiting Prof. SVNIT, Surat. Consulting Engineer, EFGE Consultant, Surat.

Geofabrics for Erosion control and Foundations, A.M.D., S.V.N.I.T., Surat, 31 Dec 2008

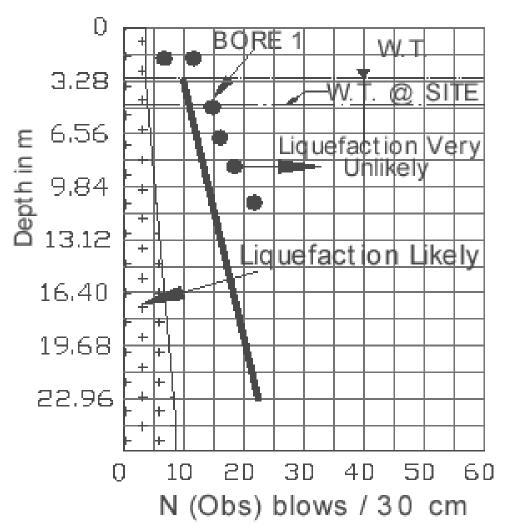
Fig. 2. Probability of liquefaction for the site using Seed & Idriss approach (1971) for 0.15g acceleration.

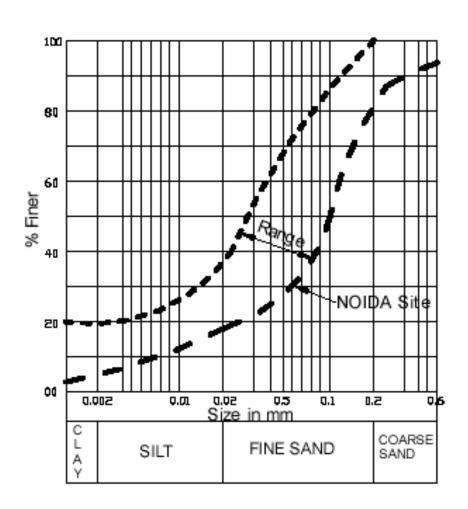
Fig.3. Grading range for top 5.0 m soils around Delhi and Noida Site. (Desai M.D., 1969)

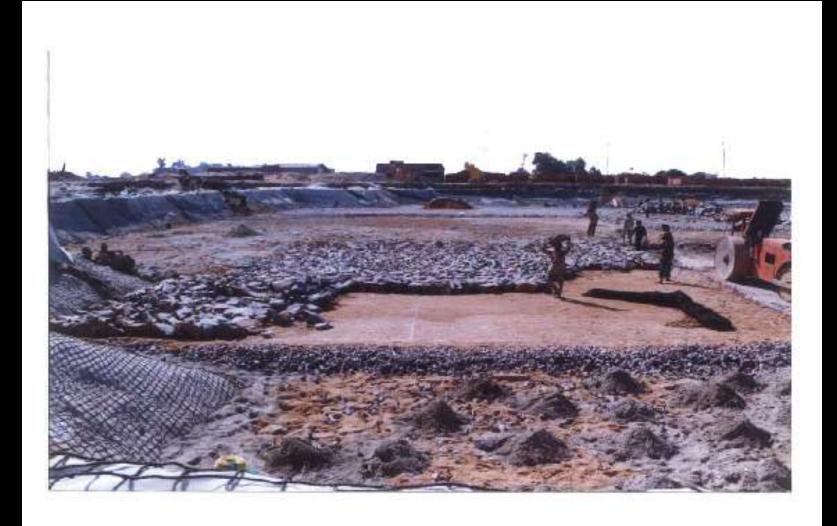
Fig.6(a). Sequential construction of the foundation system shown in fig 5 in a typical cross section

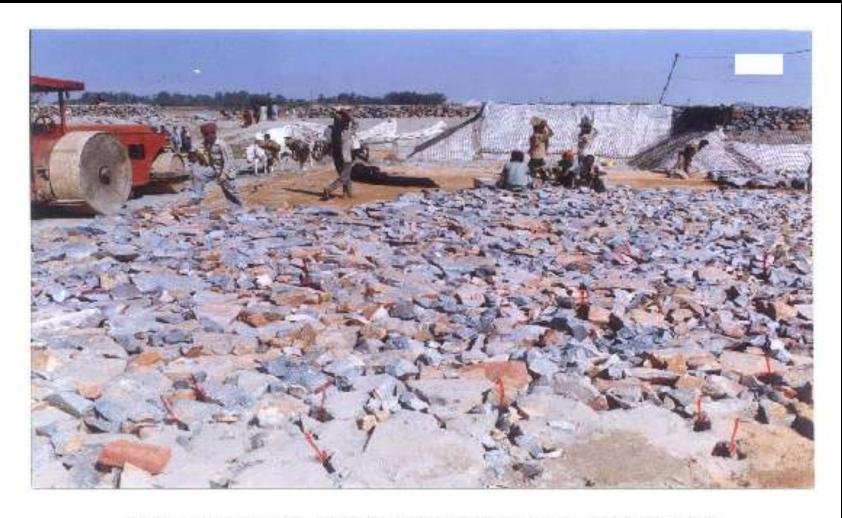
Fig.6(b). Photo plate showing the geo fabric, overlaying rope mattress and stone

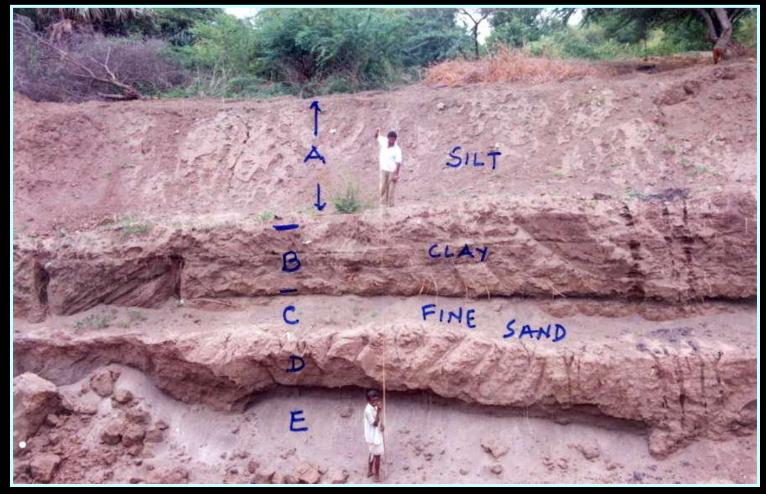
Soil stratification of left Bank. Base of Embankment. Layer C,E caused cavity by Sand flow in return tides. Collapse of Bank – Piping Perpendicular to Profile.

➤ 1996-98 Flood-Scoured deep cut on left Bank D/S of weir.Island, Channel, Bank with flood embankments.

(Danger for Pala at Bharimata, piping under Pala.)

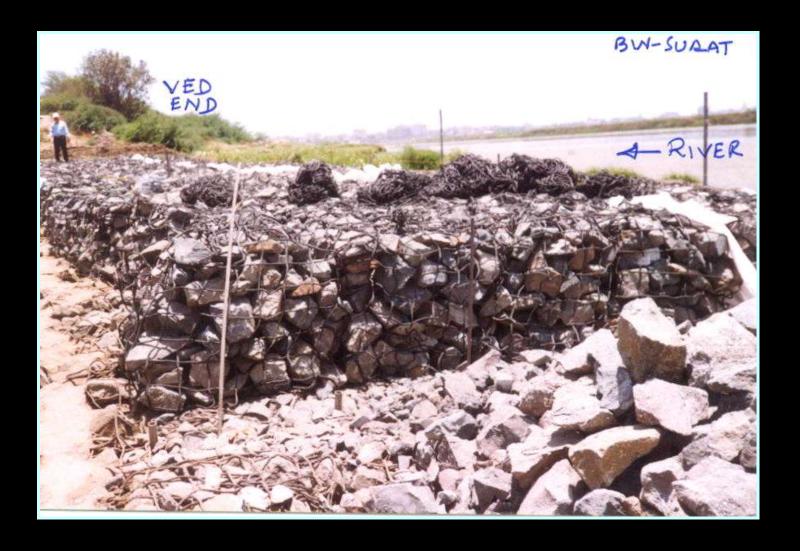
Laying of Gabbians, Filter in stages in tidal zone.

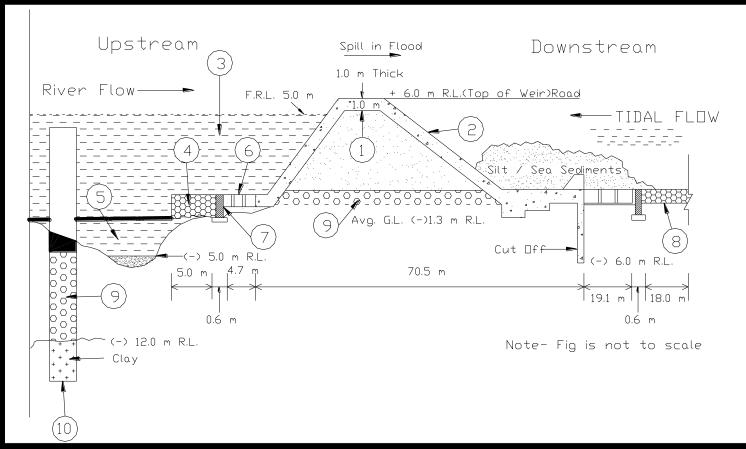
- ► FIG Cross Section of Weir Bays-Showing probability of Piping (weir Surat)
- Legends: (1) Sand fill, (2) C.C. weir floor & glacis, (3) Sweet water Pond, (4) Original loose stone Apron of stones weighing min. 40 Kg & size 300 mm upstream, (5) June '2000 Scour Pocket, (6) P.C.C. block, (7) R.C.C. toe wall, (8) Loose stone Apron, (9) Sand & Gravel (Bed Material), (10) Bore.

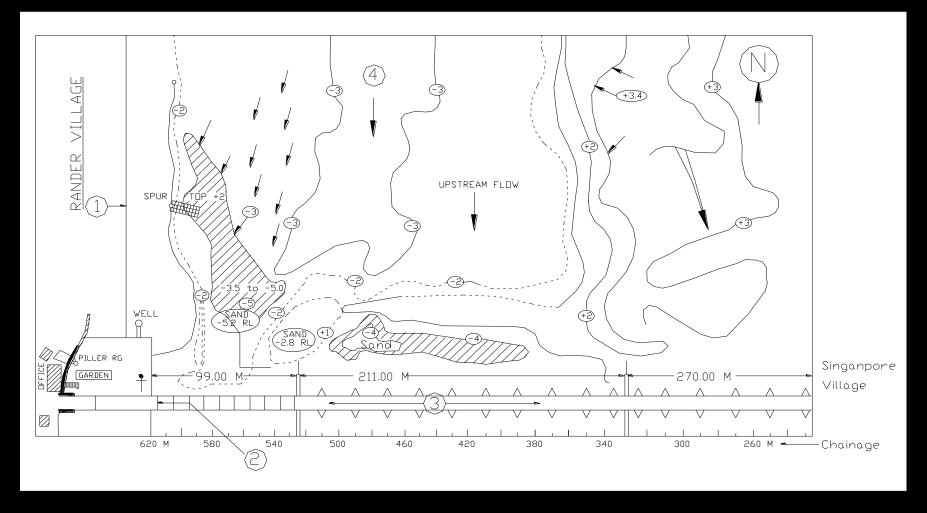
➤ FIG – Scour Pockets – Channel Formed At Upstream Of Weir, Surat.
 Legends: (1) Flood protection wall / Embankment, (2) Sluice Gate,
 (3) Weir Top, (4) Channel Formed by sand Mining in Upstream

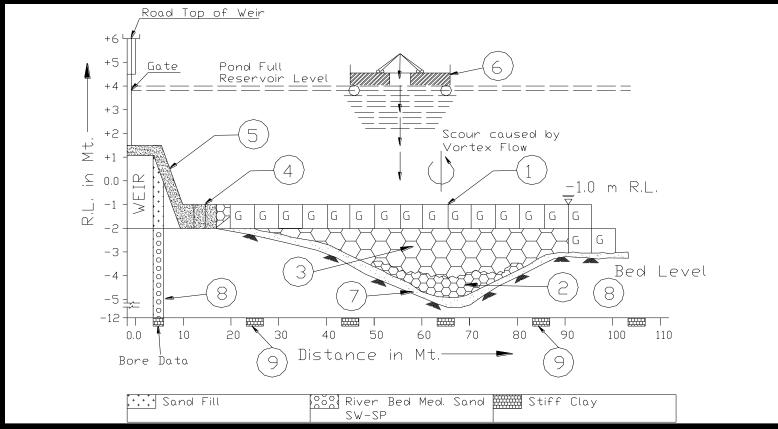
➤ FIG – Typical Cross-Section of Upstream Scour Hole Indicating,(A) Upstream concrete Top & Apron, (2) Proposed repairs

Legends: (1) Proposed Rope Gabions (G), (2) Stitched Geotextile filter bags filled with sand laid under water, (3) Dumped stone fill dropped from Pontoon, (4) Launching Apron (C.C. blocks & stone riprap),(5) C.C. weir Floor, (6) Pontoon, (7) Silt (1.0 to 2.0 m deep), (8) Medium sand, (9) Stiff clay.

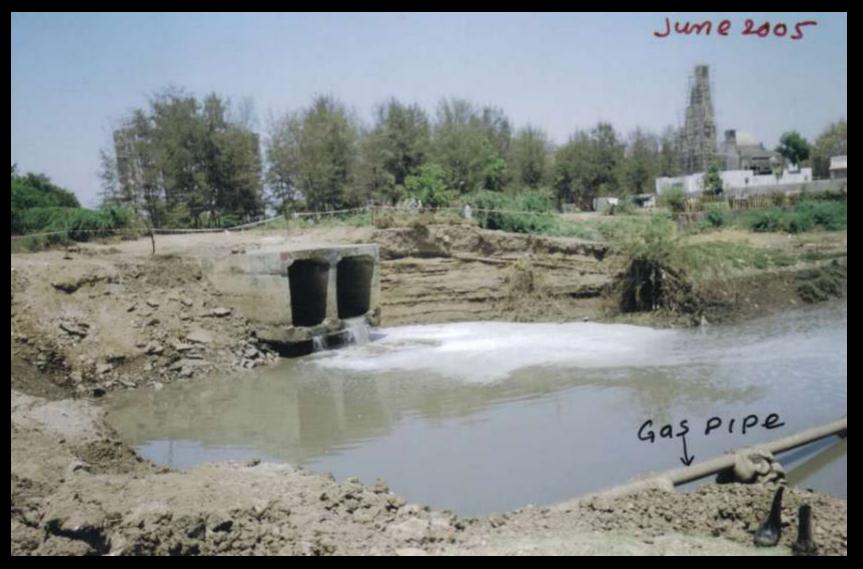
➤ Cause for bed erosion – Strom drain kotar

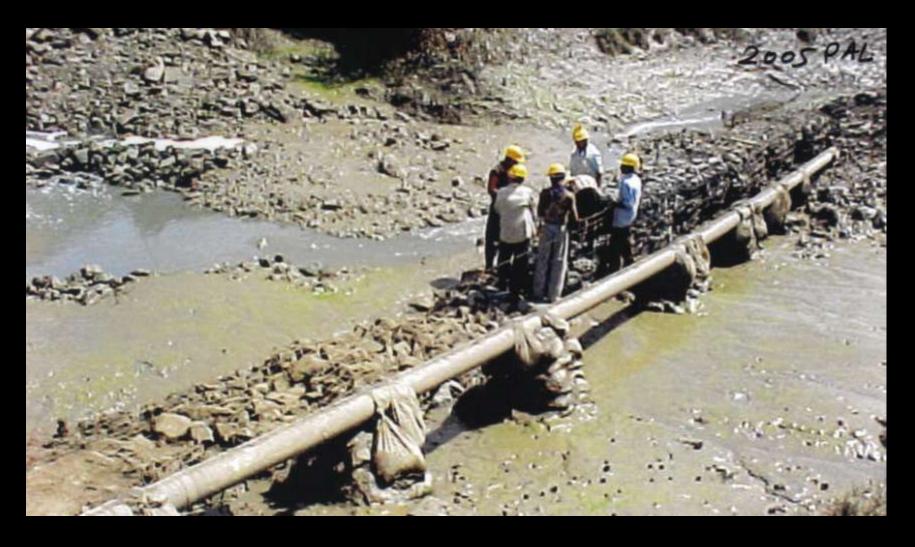
Erosion protection treatment by Gabion & Geo-filer: Geo-synthetics.

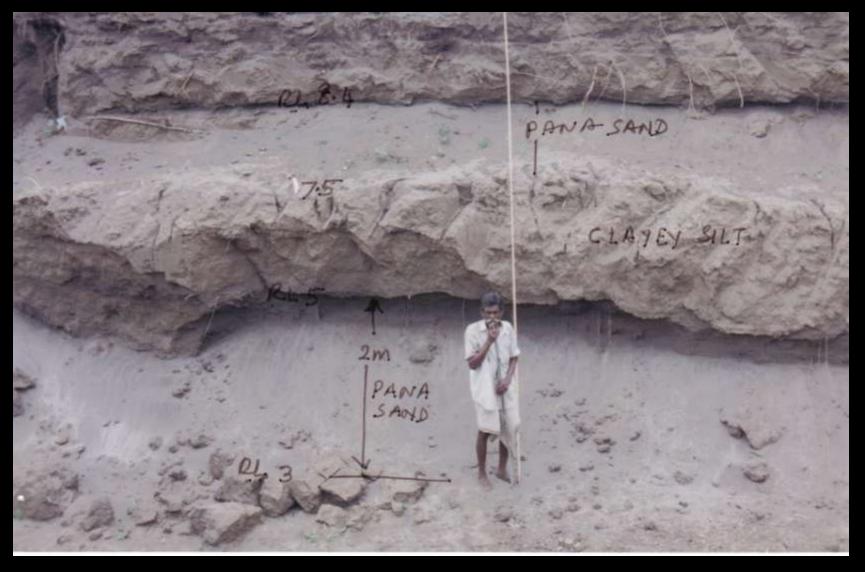
> Tapi bank erosion showing different soil strata.

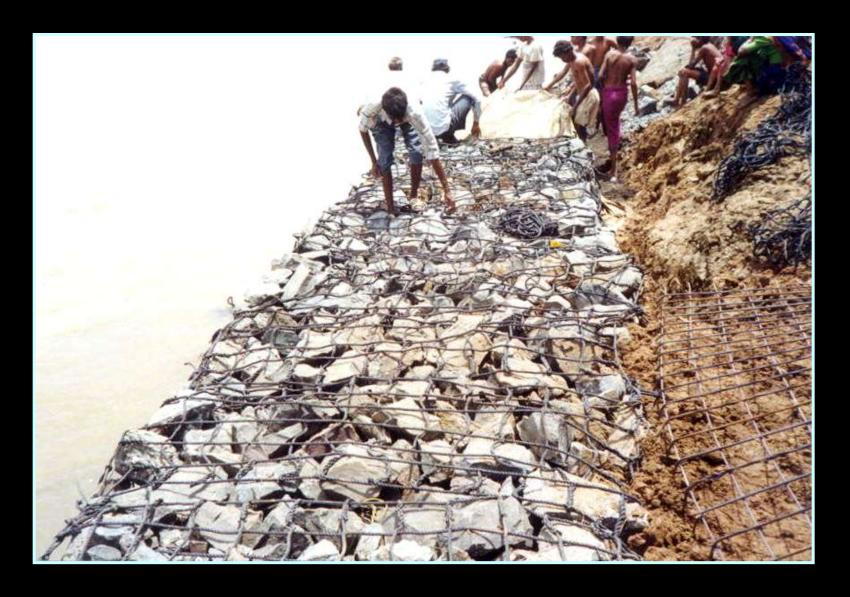
➤ Gabbian Laid in Position to Form Erosion Protection and Base for Foundation of Wall (Umra).

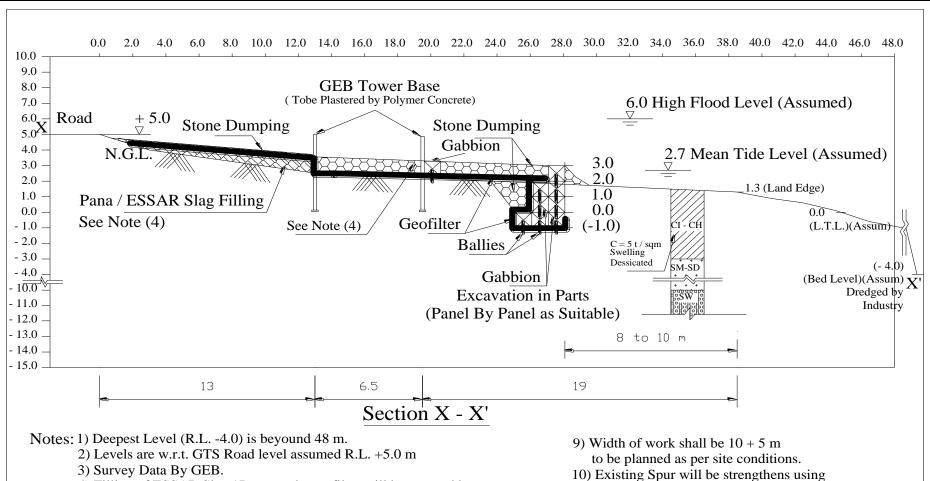
- 4) Filling of ESSAR Slag / Pana sand over filter will be covered by 500 mm thick stone packed pitching with interlock(stones > 200 mm)
- 5) Ballies 2 per Gabbion 1.5 m at G.L. and 1.0 m between Gabbions 2" Dia.
- 6) Soil Profile is assumed from data base.
- 7) Geo filter thicker than 40 g / sqm Joined by 75 mm overlap e pins.
- 8) Projected C.C. Legs of tower will be cleaned & covered by 40 mm polymer plaster with binder coat.
 - Fig 1 (b): Typical Cross Section for Tower No: 18 A (Foundation Protection)

10) Existing Spur will be strengthens using Ballies, Stones / Gabbions to R.L. + 3.0.

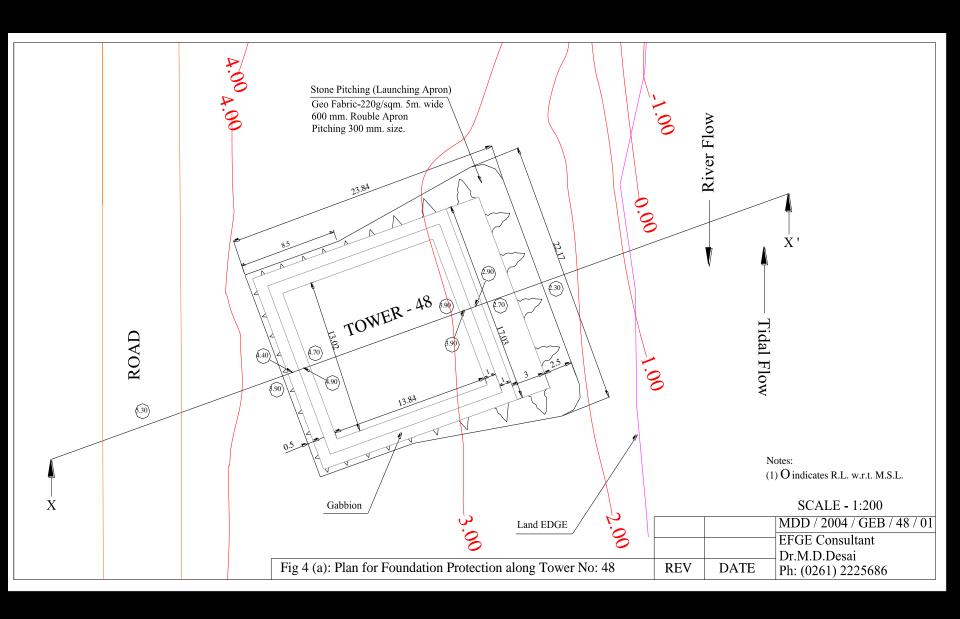
SECTION - X X'

CROSSING	ROAD							TOWER 48							LAND EDGE													
	5.190	5.300	5.349	5.286	5.003	4.549	4.095	3.927	3.810	3.687	3.572	3.473	3.373	3.269	3.170	3.075	2.932	2.753	2.545	2.339	2.209	2.054	1.837	1.263	0.759	0.200	-1.00	-1.50
CHAINAGE	0.000	2.000	4.000	6.000	8.000	10.000	12.000	14.000	16.000	18.000	20.000	22.000	24.000	26.000	28.000	30.000	32.000	34.000	36.000	38.000	40.000	42.000	44.000	46.000	47.491	50.000	53.000	56.000

MDD/ 2004/ GEB/ 48 / 02
			EFGE Consultant Dr.M.D.Desai
Fig 4 (b): Cross - Section along Tower No: 48	REV	DATE	Ph: (0261) 2225686

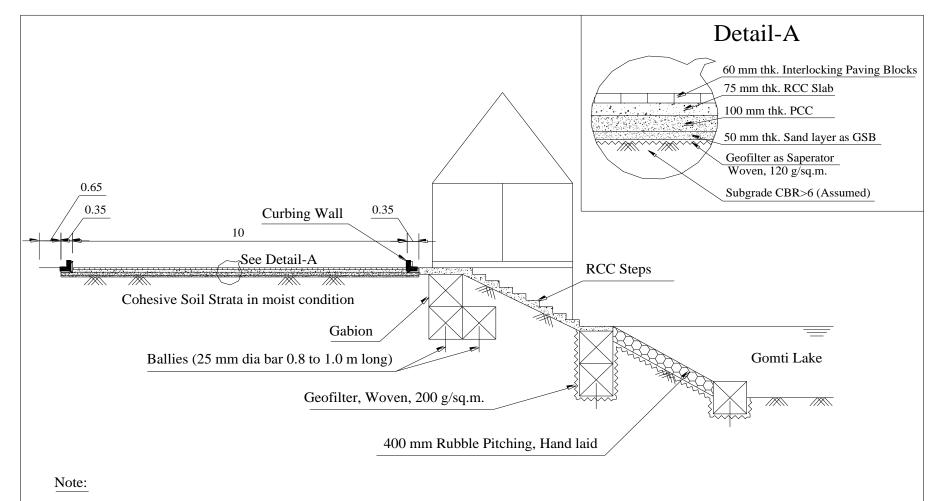
- 1. Assumed in working season the Gomti Lake will be in dry condition.
- 2. SBC of existing soil below the Gabions is assumed as 15 t/sq.m.

Fig. 1: Sketch showing proposed protection works at Gomti Lake.

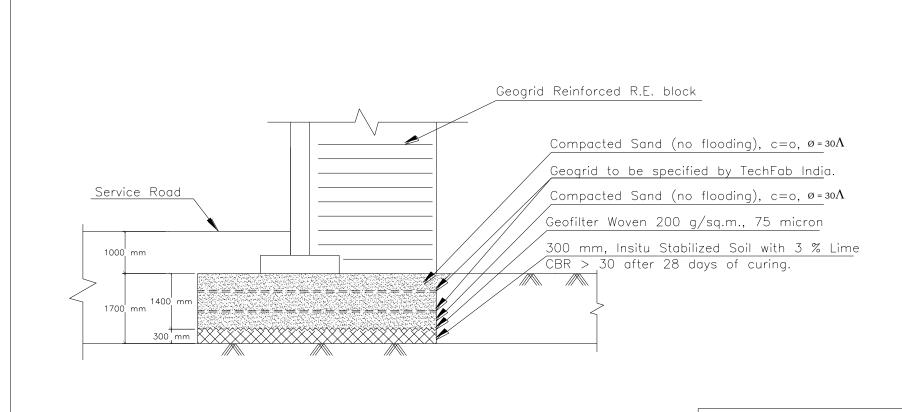
MDD/L&T-RE WALL/Fig.2

Fig. 2: Sketch showing ground treatment at Por Cross Road.

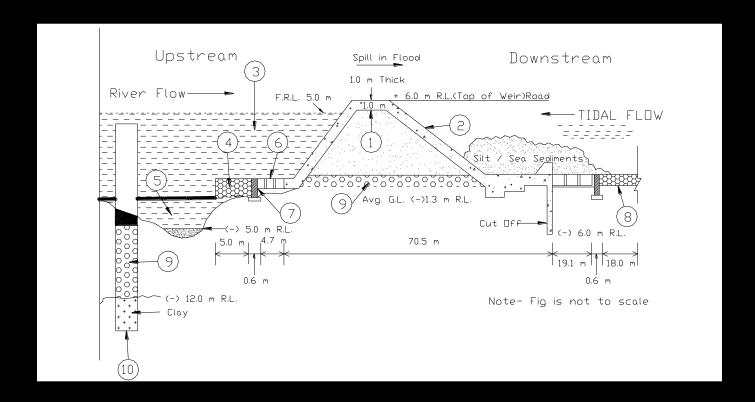
FIG 2: – Cross Section of Weir Bays-Showing probability of Piping (weir Surat)

Legends: (1) Sand fill, (2) C.C. weir floor & glacis, (3) Sweet water Pond, (4) Original loose stone Apron of stones weighing min. 40 Kg & size 300 mm upstream, (5) June '2000 Scour Pocket, (6) P.C.C. block, (7) R.C.C. toe wall, (8) Loose stone Apron, (9) Sand & Gravel (Bed Material), (10) Bore.

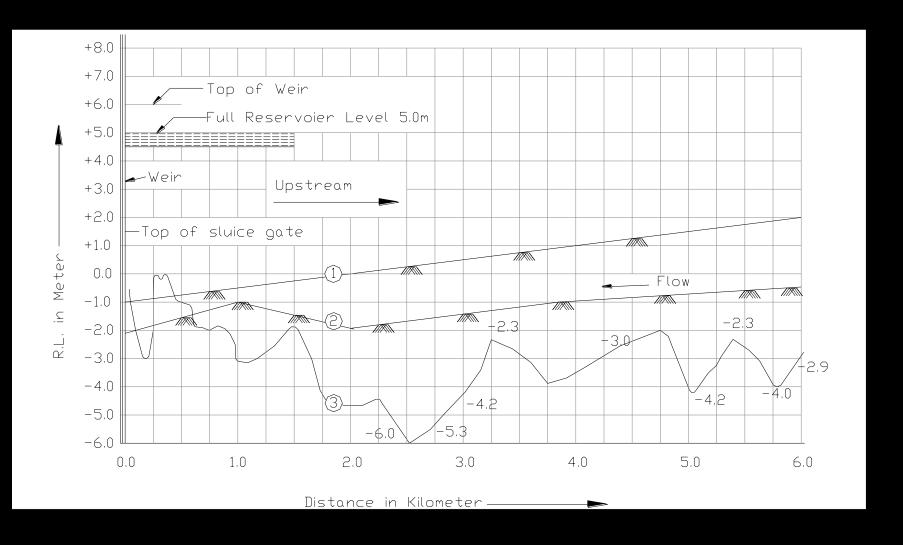
FIG 3: – River Channel Deepest Bed Profile Based On Surveys: (1) Aprox. For 1990, (2) For year '98, (3) For year 2000.

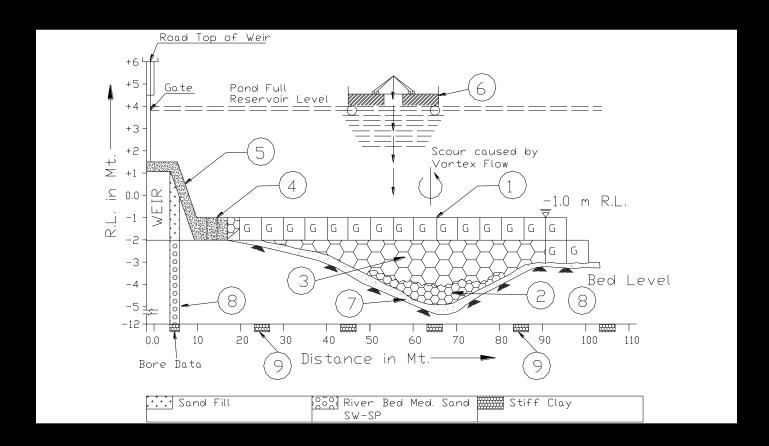
FIG 5: – Typical Cross-Section of Upstream Scour Hole Indicating,(A) Upstream concrete Top & Apron, (2) Proposed repairs

Legends: (1) Proposed Rope Gabions (G), (2) Stitched Geotextile filter bags filled with sand laid under water, (3) Dumped stone fill dropped from Pontoon, (4) Launching Apron (C.C. blocks & stone riprap), (5) C.C. weir Floor, (6) Pontoon, (7) Silt (1.0 to 2.0 m deep), (8) Medium sand, (9) Stiff clay.

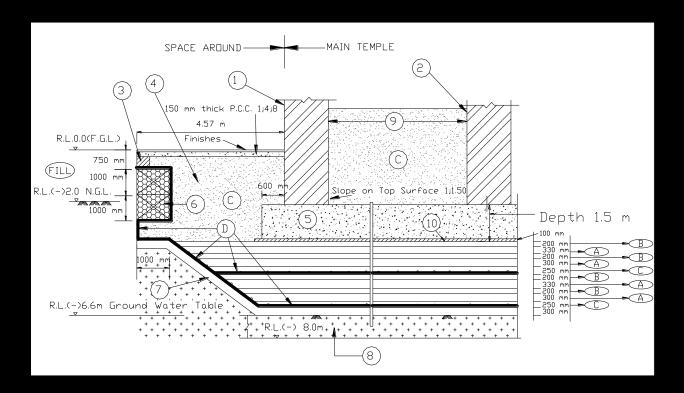
FIG 10: - Flexible Foundation System – Typical Section

Legends:(1) Face of outer plinth wall (2) Outer face of inner plinth wall (3) 345 mm thick brick wall (4) Compaction on either side of gabion wall carried out simultaneously to ensure that gabion does not act as retaining wall (5) Fiber reinforced PCC 1:2:4 (6) Gabion wall 2m High (7) Compacted Thick stone soling (8) Insitu sand compacted by 10 T pneumatic tyred roller to density 1580 Kg/ Cu.m. (9) Monument foundation of hexagonal cell of brick masonry (Special bricks of 120 Kg/Sq.cm. strength) (10) 100 mm thick P.C.C. 1:4:8.

(A) Boulders (size not less than 175mm) with smaller in filling stones and quarry spoil/stone screening rolled with 10 T roller eight times, (B) Boulders (size 90mm – 40mm) with smaller in filling stones and quarry spoil/stone screening rolled with 10 T roller eight times, (C) Compacted sand, (D) Geocomposite (1) Geonet (rope mattress)-(8mm dia @ 150 c/c) (2) Geofilter (40 gm / Sq.m –220)
